Town: 263 - WINDSOR

IDENTIFICATION	
(1) State Names	50 - Vermont
(8) Structure Number	101423002714231
(5) Inventory Route	1
(2) Highway Agency District	4 - District 4
(3) County Code	27 - WINDSOR

Team Lead: Justin White, **Inspection Date:** 09/29/2023

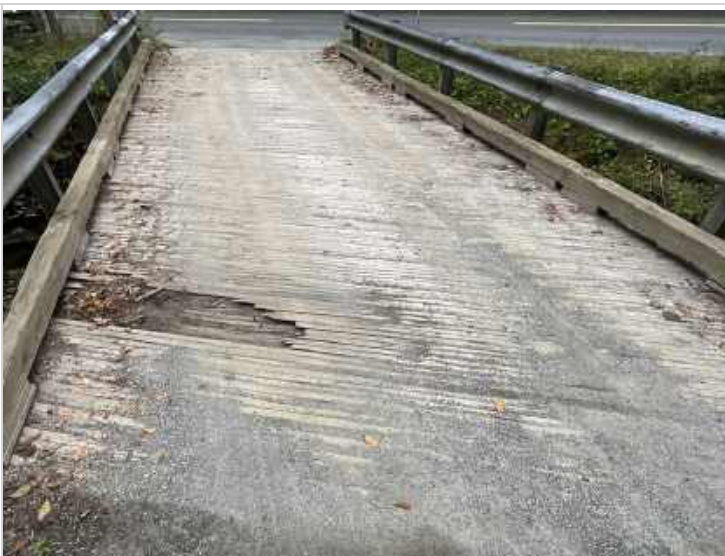
Wearing surface

See deck comments.

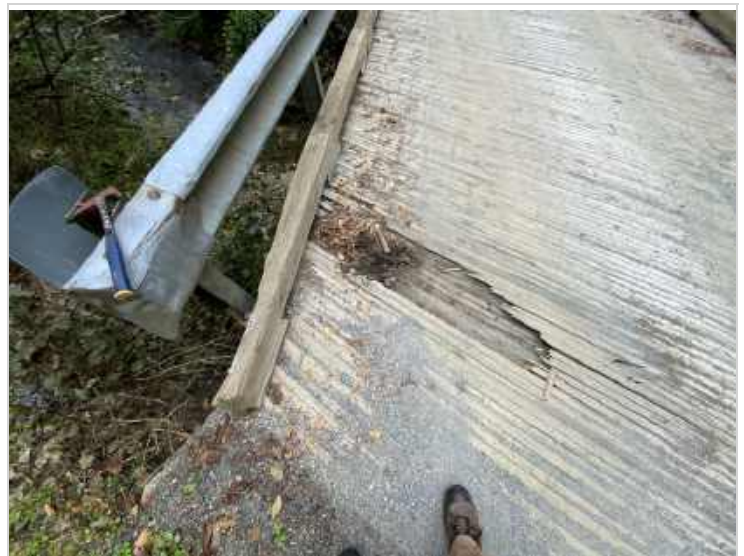
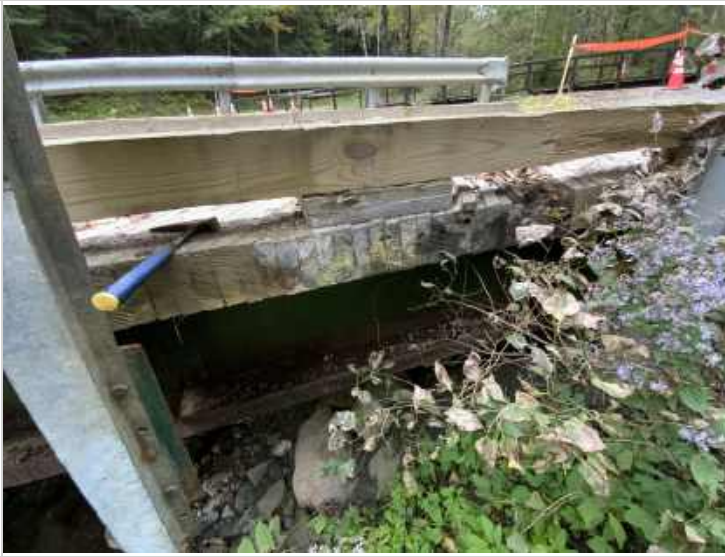
Abutment 2 downstream end of deck

Areas of moderate to heavy saturation is visible along the beam flanges. The downstream end over abutment 2 the wearing surface has a 16"x 8' area where the top edge of the deck boards have broken out or are still peeling away, with heavy saturation and fungus growth visible in the soffit. Within this area 3' of the outer end is heavily rotten due to saturation held in place from the sand that has filled in this area. Further rot and fungus growth is visible along the board ends abutting this area extending under the anchored curb support.

The deck has developed a large area of rot over the downstream end of abutment 2 with fungus growth visible in the soffit. A project to replace the timber deck should be considered, see maintenance report.

Type of Work: 8 - Deck - Deck replacement

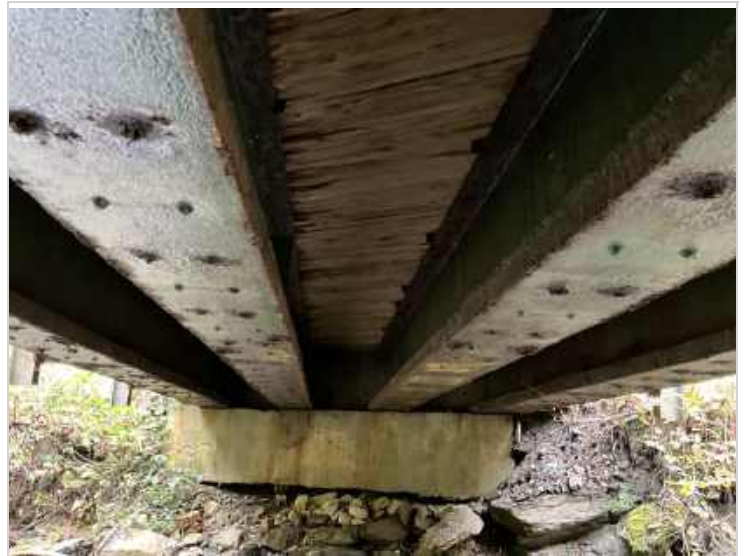
Deck/Superstructure

59 - Superstructure (6 - SATISFACTORY CONDITION - structural elements show some minor deterioration.)
 Rust scale with minor to moderate section loss along the flanges and lower areas of the webs throughout.

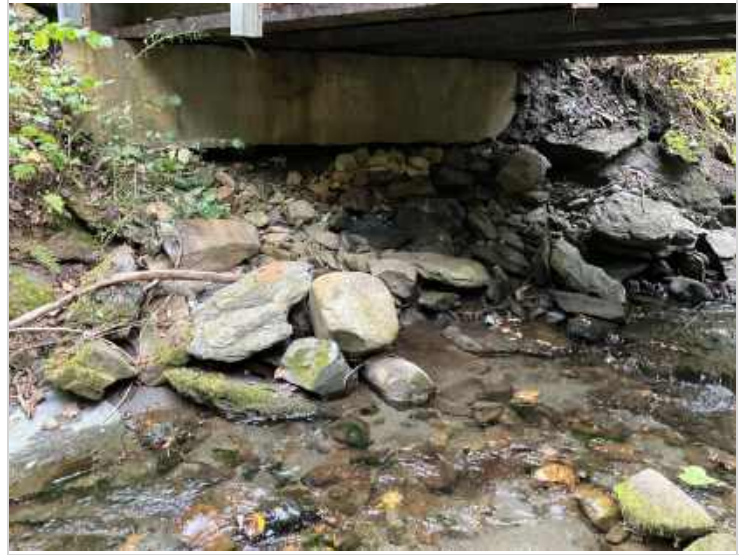
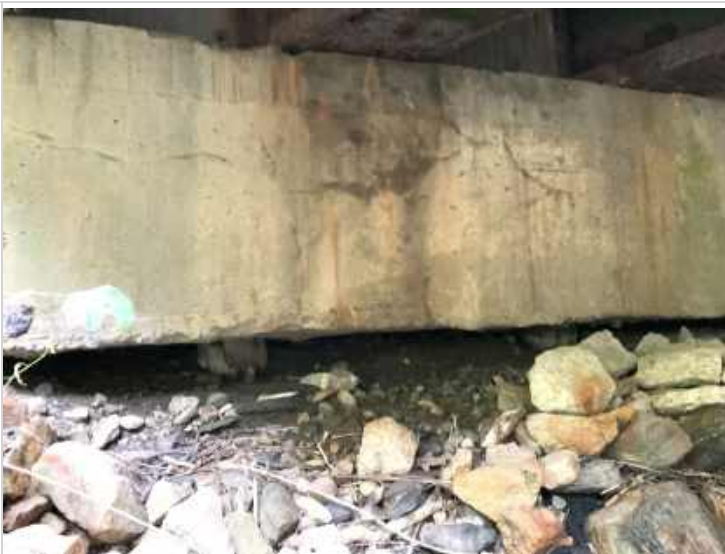
Abutment 1

Scattered fine map cracks with light staining. There is minor undermining of abutment 1 extending vertically as much as 9" and penetrating 2'-8" beyond the abutment face, undermining has exposed the timber piles.

61 - Channel Condition (6 - Bank is beginning to slump. River control devices and embankment protection have widespread minor damage. There is minor stream bed movement evident. Debris is restricting the channel slightly.)
 Settlement and erosion of the abutment 1 embankment has caused undermining along the length of the abutment, exposing two timber piles and penetrating at its deepest point 2'-8" below beam 3.

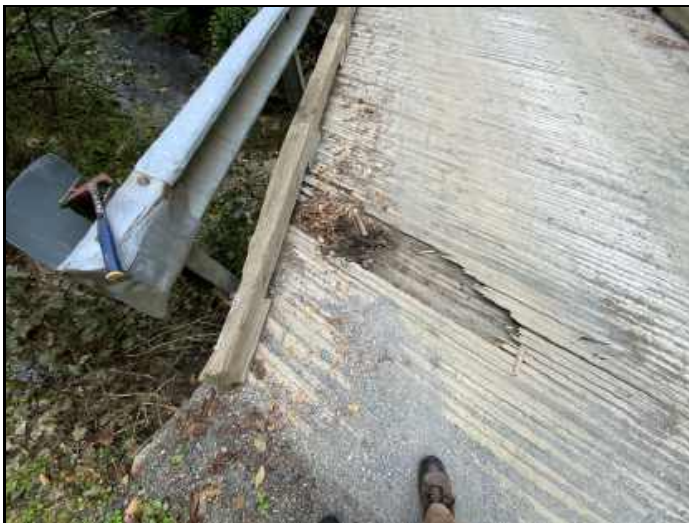
Abutment 2 downstream end of deck

Areas of moderate to heavy saturation is visible along the beam flanges. The downstream end over abutment 2 the wearing surface has a 16"x 8' area where the top edge of the deck boards have broken out or are still peeling away, with heavy saturation and fungus growth visible in the soffit. Within this area 3' of the outer end is heavily rotten due to saturation held in place from the sand that has filled in this area. Further rot and fungus growth is visible along the board ends abutting this area extending under the anchored curb support.
